# Information Sheet

Archaeology Series No.2

## THE STONEBOW AND THE GUILDHALL

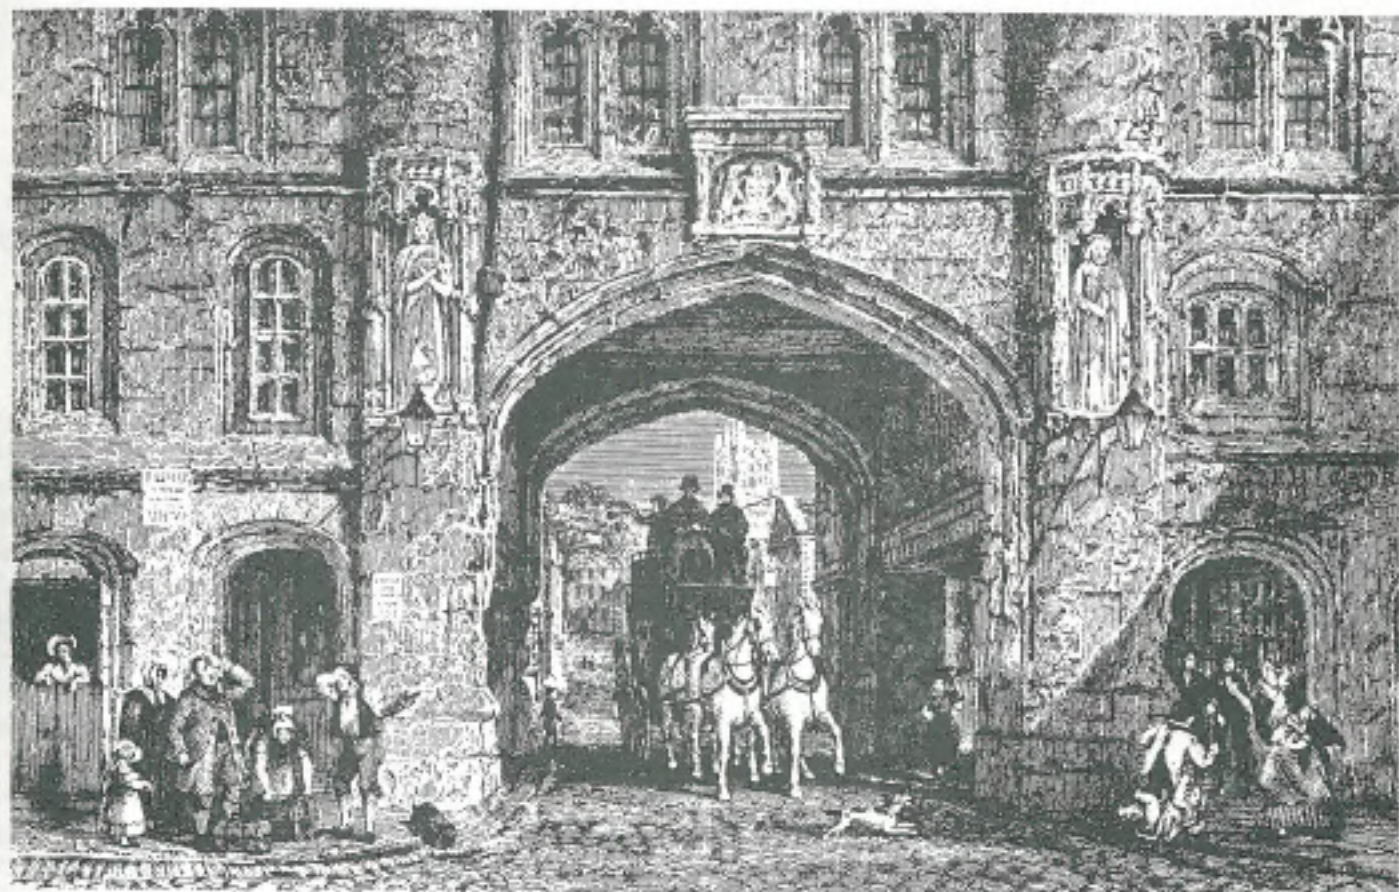
*An engraving of the Stonebow published by Havell in 1836*

The two ranges have been altered a number of times. The west range seems to have always had one pedestrian archway, but until the 1880s the outer of the two side archways was a doorway leading into a room behind, and this is shown quite clearly on prints and drawings, like the example on page 1. The modern doorway now on its west side was

On the east side of the gateway, there are today two passages. As with the west side, this was not always the case. The inner archway is recorded in the City Minute Books as having been ordered opened for passengers in 1758. What this means is not altogether clear, and it is possible that it refers to the opening up of an original passageway which had been previously blocked, rather than the creation of an entirely new passage. If this were the case, it would balance the west side and more especially be in keeping with the style of archway. The outer archway was created in the restoration programme of 1885-87, and until that date had been a window, and is shown as such on most earlier illustrations. The arcading on either side of the two passageways is similar to that on the west side of the gate and belongs to the same period of restoration. A plaque inside the gateway records the date of this work. As with the west side the floor of the room above the inner passageway was supported by a beam running between the inside faces of the two eastern gate-towers, and in the west wall of this room a window looked into the gateway (see illustration on page 1).

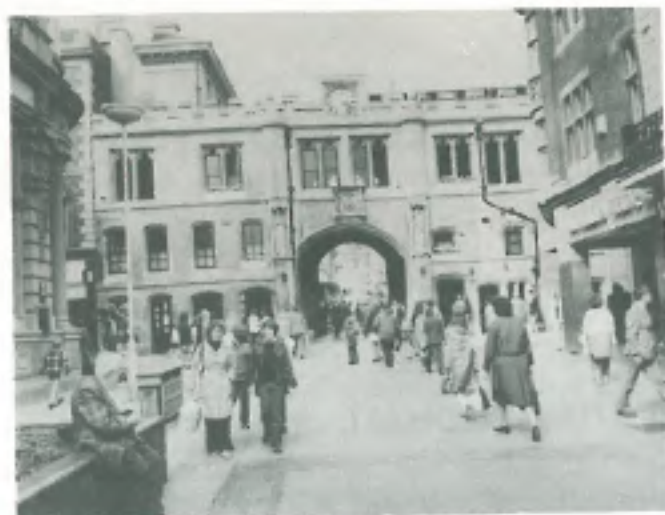
*The Stonebow today from the south*

As you look at the Stonebow today from the south, the gateway looks much as it would have done in the sixteenth century, although a number of changes, in some cases quite radical, have taken place since that date. On either side of the main arch are commercial and domestic premises at first and ground floor level which have been leased by the City to a variety of tradesmen and private individuals through the years. The earliest records we have date to 1515 when the east range was in the hands of a taverner. The two ranges are not of the same date, which shows quite clearly in the different architectural detail of the doorways and windows. The range on the east side, with its heavy hood mouldings over the archways and windows supported by carvings of grotesque and human heads (some of which are later replacements) dates broadly from the mid-late fifteenth century, while that on the western side with its much plainer, larger windows and doorways can be placed in the late fifteenth-early sixteenth century. This difference in building is not surprising when we remember that the Stonebow was being built over a considerable length of time.

The iron tie-bars, the decorative ends of which can be seen on ground and first floor level, were inserted during the 1885-87 restoration work to prevent further slippage of the gate-

way. The buttresses against the east range are undated, but were presumably built later than the windows as they cut through their hood mouldings. The need for both tie-bars and buttresses is apparent when we look at the main arch of the gate, which is badly contorted and leaning outwards. The reasons for this are not certain, but one possibility is the presence of an early town ditch running parallel with the town walls in front of the gate, the soft filling of which would be much more unstable than the ground on either side, and could cause such settlement. There is, however, no archaeological evidence at present for a ditch in front of the town wall on this side of the town, and poor foundations may simply be the answer.

On either side of the gate arch is a shallow, projecting tower, incorporating an elaborate canopied niche at first floor level. The west niche holds a statue of the Virgin Mary, patron saint of the City and Cathedral, while that on the east has a much restored statue of the Archangel Gabriel holding a scroll in his left hand and a palm branch in his right. He is supported by two winged beasts, while Mary is supported by a winged serpent with a human head on either side. The two statues represent the Annunciation. Above the centre of the arch, and placed rather awkwardly across the middle string course are the arms of King James I (1603-1625). On either side of the statues are the arms of the City of Lincoln, a single gold fleur-de-lys on a red cross on a silver shield.

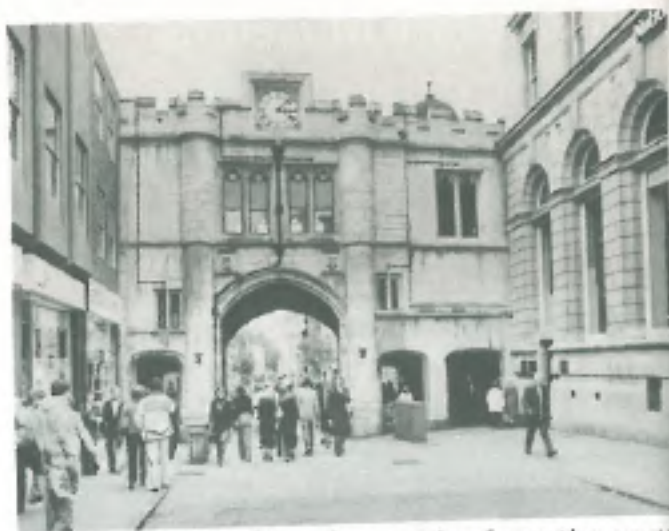
*The Stonebow today from the north*

The north face of the Stonebow is, not surprisingly, much plainer than the south and has been heavily restored. The towers are repeated on this face but they lack the canopied niches. To either side of the towers is a small square window. Until the 1880s the west side of the gateway had been largely obscured by buildings fronting onto the High Street, but in 1883 a fine new bank building, now the National Westminster Bank, was erected some 10-12 ft (3-4 m) further west and much of the west face of the Stonebow was exposed. In 1885 the City Council asked the architect J.L. Pearson to draw up plans for a major programme of restoration work on the Stonebow and Guildhall. Letters and documents in the County Archives office and photographs housed in Lincoln City Library provide detailed information about this work. Pearson almost totally rebuilt the western side of the north face of the Stonebow. He inserted a new window in sixteenth-century style at second floor level after demolishing an earlier brick chimney and continued the string courses across the face of the building. He also continued the parapet to the western end of the building. The extent of his work can be seen in the marked contrast between the old and new stonework.

But more important were the considerable changes he made to the ground floor. As we have already seen, the arcading on either side of the passageways is of this date, and on the north side of the gateway, the westernmost archway is also a new creation, and is of a

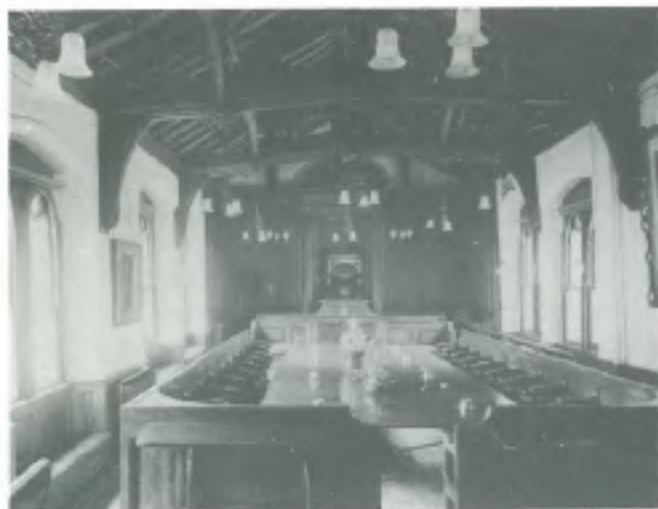
*Interior view of Guildhall*

But the chief glory of the Guildhall is its magnificent open timber roof. Each of the massive tie-beams is supported by braced wall posts the feet of which are carved with animal, human or mythical faces. The tie-beams bear king-posts with large braces, while on either side of the room the purlins are supported by arched braces. The bosses on the underside of the tie-beams are of interest, mostly carved with rose or foliage motifs while one on the middle tie-beam is carved with four faces.
