Archaeology Series No.4

NEWPORT ARCH, LINCOLN

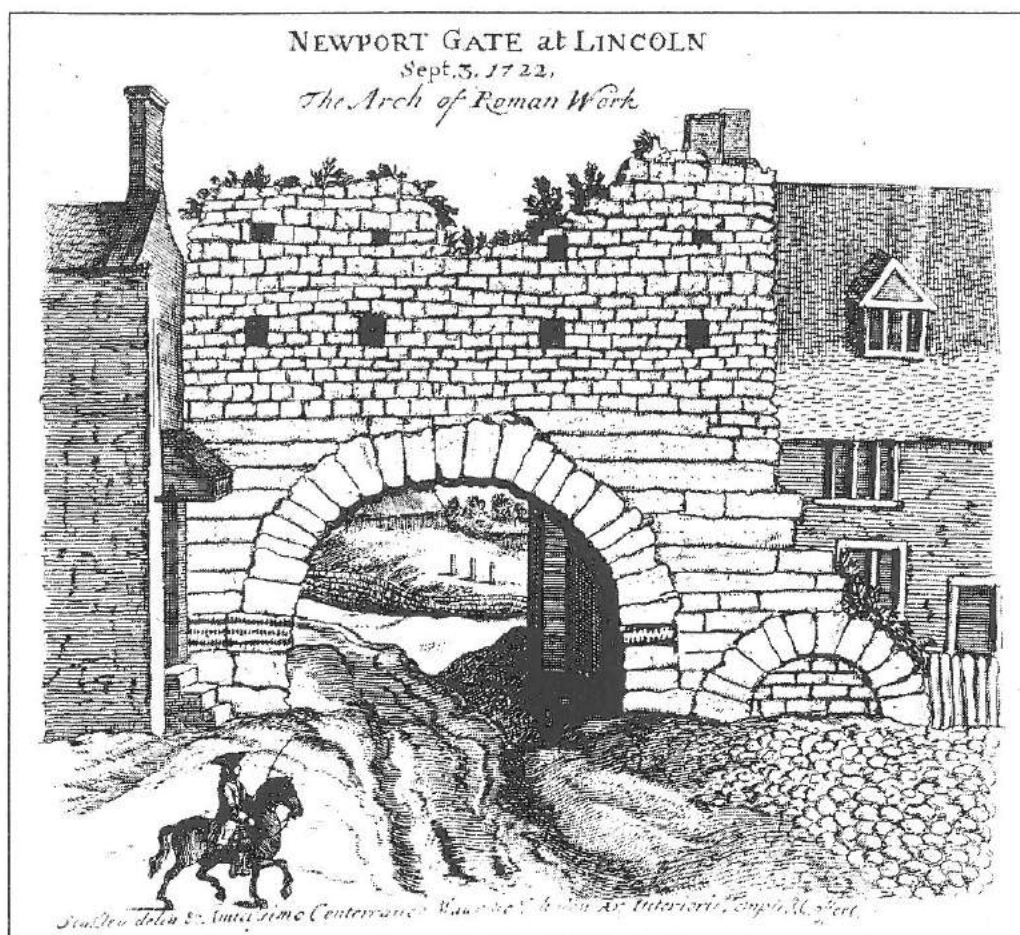
Fig. 1 Newport Arch from the south, by William Stukeley, 1722

The earliest surviving drawing of Newport Arch is by the Lincolnshire antiquary, William Stukeley (1687-1755), which shows the south side of the gate in 1722 (Fig. 1). Above the central archway were eighteen courses of small stone blocks with two rows of square 'putlog' holes, designed to locate timber scaffolding poles, while on the eastern side was a smaller archway for pedestrians which at some unknown date had been blocked with stone. Today much of the superstructure visible in the eighteenth century has disappeared, and the side passage, which had served in the latter part of the eighteenth

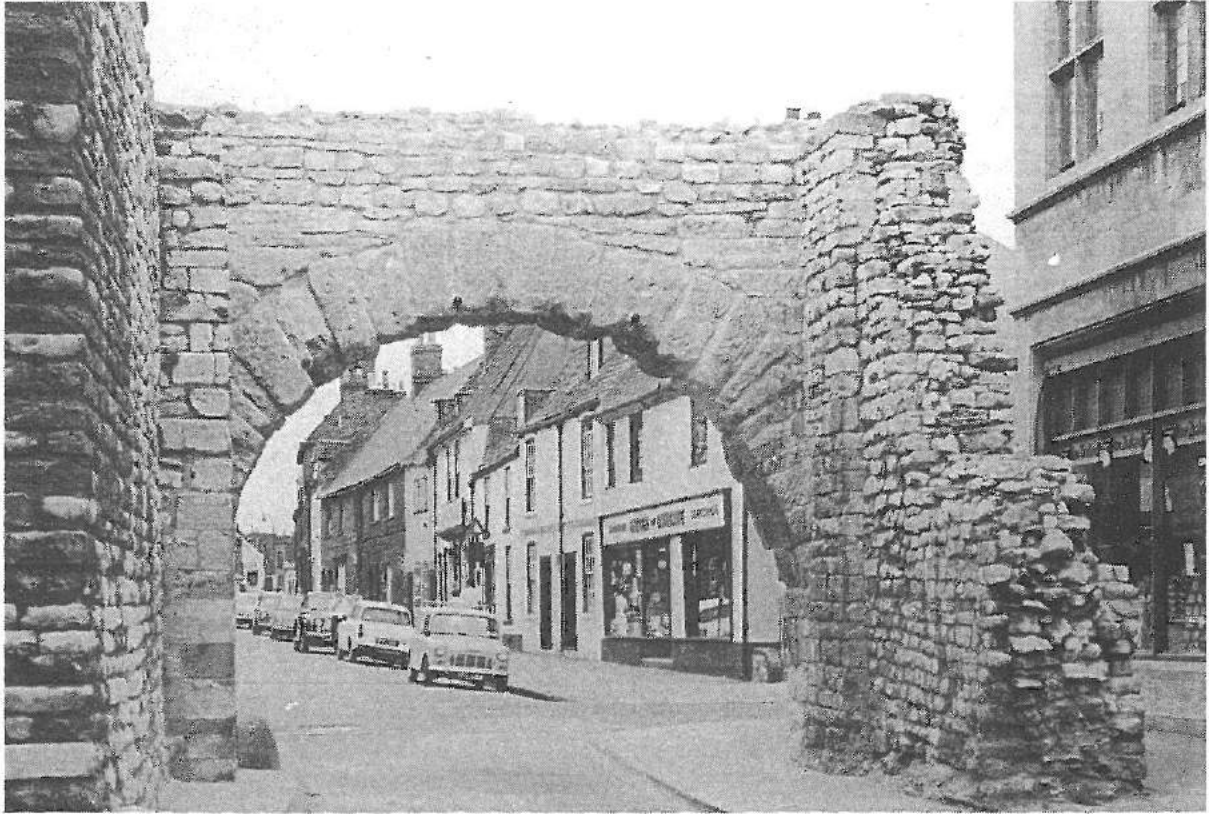
Fig. 5 Newport Arch from the north

The two stone walls projecting from the north side of Newport Arch are of mediaeval date, and are all that remains standing above the modern ground surface of the mediaeval successor to the Roman gate. The 1954 excavations showed that the Roman gate had been mostly destroyed by the time the mediaeval gate was constructed and that its layout was different to that of its predecessor. Gone were the two pedestrian

little to the north-west of Newport Arch. The difference between the modern and Roman ground levels is easily seen here, and something of the scale of the Roman gateway can be appreciated. The mediaeval masonry footings overlying the Roman gate tower can be clearly seen and these have been cut through to show the front face of the western Roman side passage. It is important to note that the modern ground surface is some 2.4-3.04m (8-10ft) higher than the original Roman ground surface and this build-up in ground level gives Newport Arch today its somewhat squat appearance.

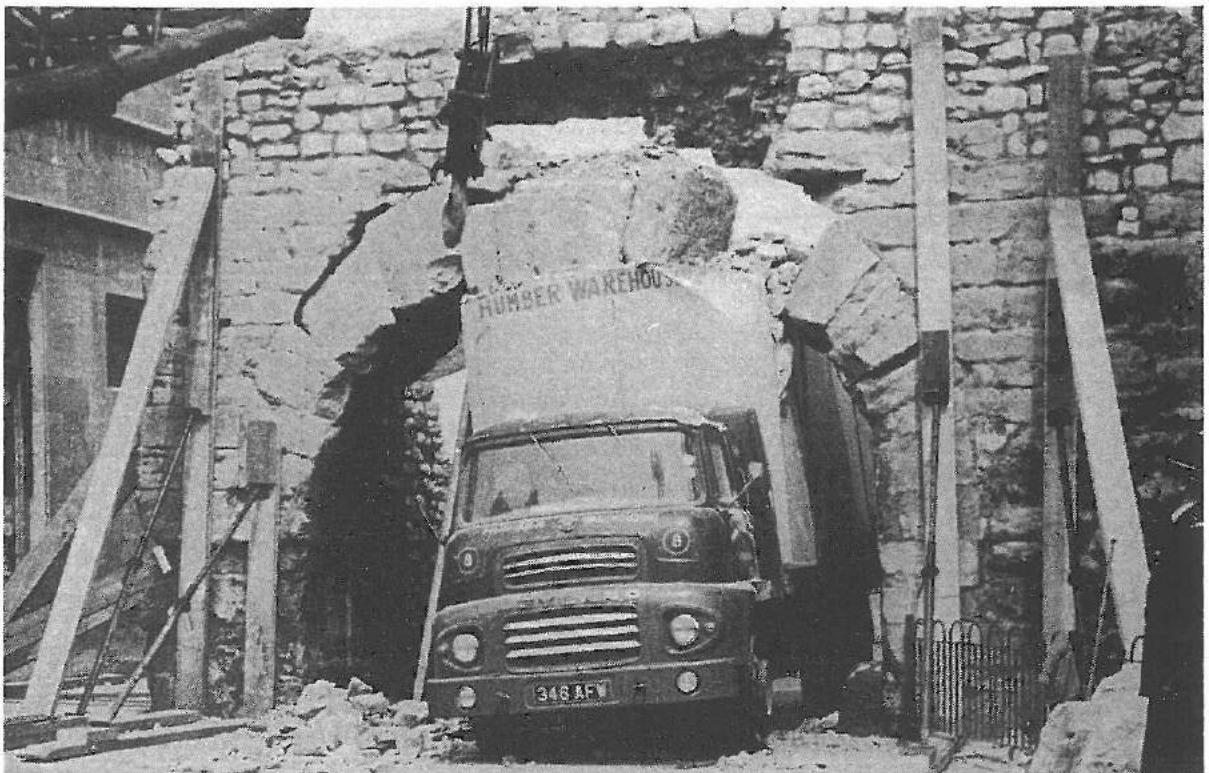
Fig. 6 The 1964 disaster

In May 1964 a heavy lorry travelling south through Newport Arch struck one of the stones in the arch. The crown of the arch and part of the superstructure collapsed on to the roof of the lorry. In the restoration which followed, the stones were each numbered and their positions recorded before they were removed by crane and the lorry released. The damage to the arch was found to be far more serious than originally believed, and almost the entire arch ring had to be removed and reconstructed around a timber framework. The operation was carried out by the City Engineer's Department and the Inspectorate of Ancient Monuments Works Department, and took place between 18th May and 3rd August 1964, when the gate was once again open to traffic.
